ADA ÖLÇÜ KROKİSİ

İLİ : HATAY
İLÇESİ : ARSUZ
MAH./KÖY : KARAHÜSEYİNLİ
ADA/PARSEL NO: 1/1,2

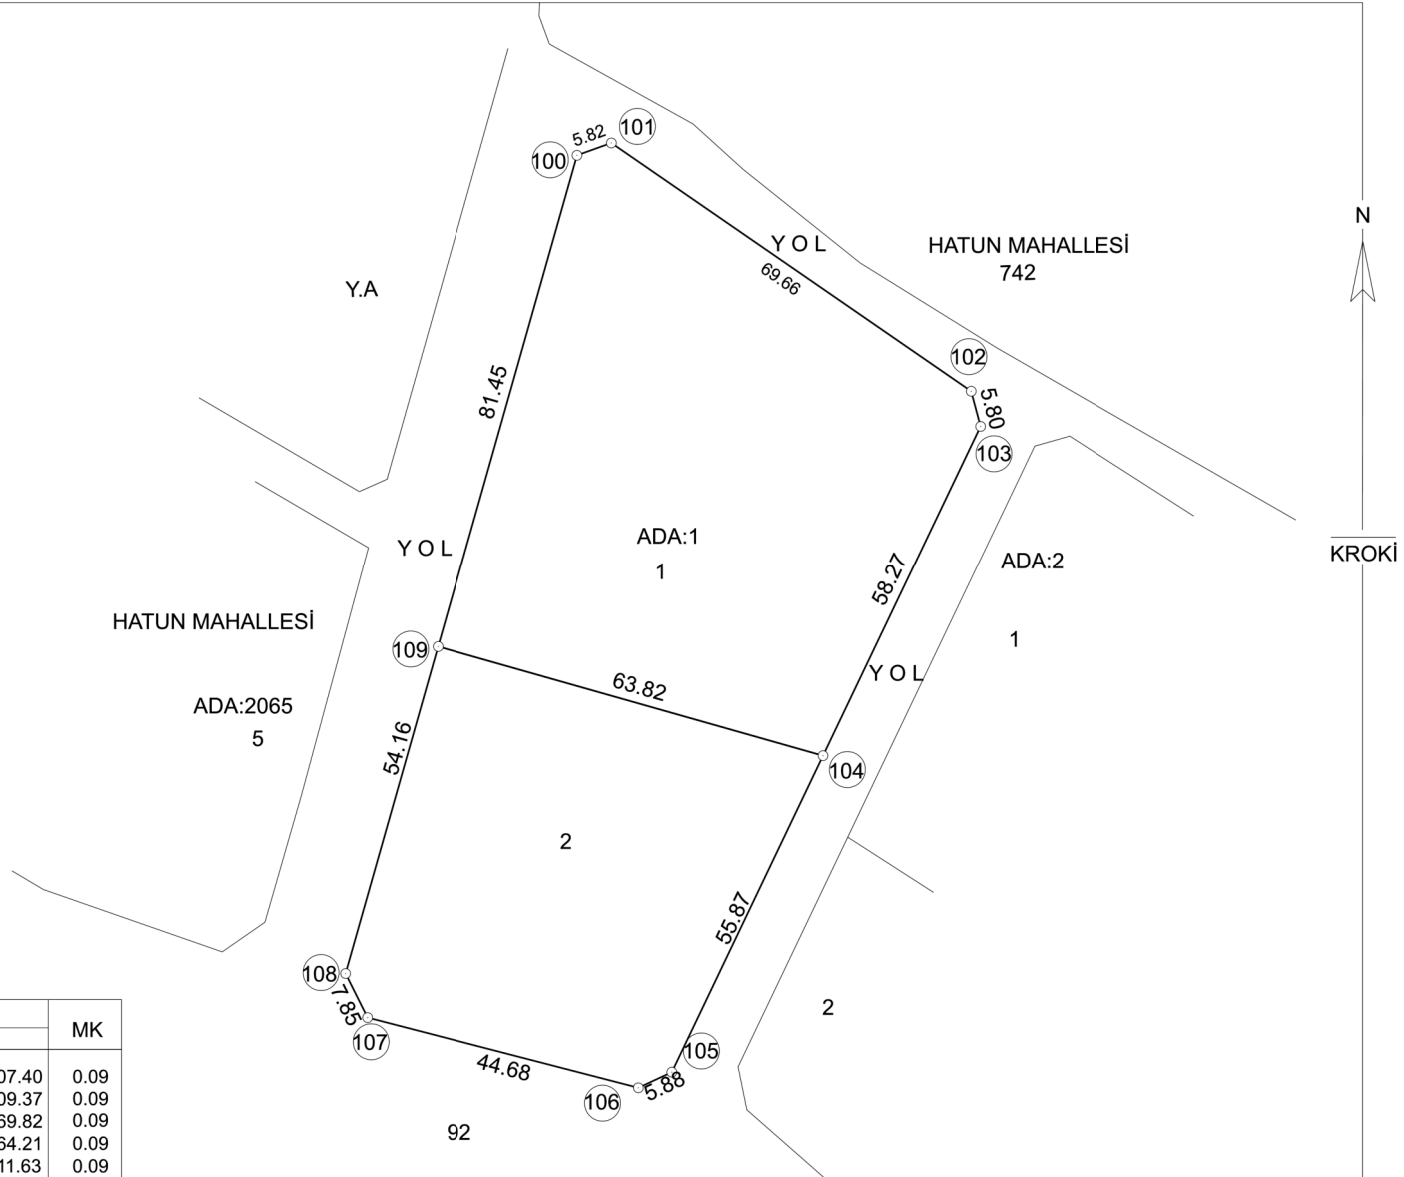
KOORDİNAT ÖZET

Nokta No	Deprem Öncesi		Deformasyon		Nokta No	Deprem Öncesi		MK
	Y	X	DY	DX		Y	X	
100	508860.24	4045807.63	0.37	0.23	100	508859.87	4045807.40	0.09
101	508865.72	4045809.60	0.37	0.23	101	508865.35	4045809.37	0.09
102	508923.05	4045770.05	0.37	0.23	102	508922.68	4045769.82	0.09
103	508924.55	4045764.44	0.37	0.23	103	508924.18	4045764.21	0.09
104	508899.44	4045711.86	0.37	0.23	104	508899.07	4045711.63	0.09
105	508875.36	4045661.44	0.37	0.23	105	508874.99	4045661.21	0.09
106	508870.02	4045658.95	0.37	0.23	106	508869.65	4045658.72	0.09
107	508826.76	4045670.14	0.37	0.23	107	508826.39	4045669.91	0.09
108	508823.26	4045677.15	0.37	0.23	108	508822.89	4045676.92	0.09
109	508838.03	4045729.26	0.37	0.23	109	508837.66	4045729.03	0.09
