ADA ÖLÇÜ KROKİSİ

İLİ	: HATAY
İLÇESİ	: ARSUZ
MAH./KÖY	: KARAHÜSEYİNLİ
ADA/PARSEL NO:	2/1,2

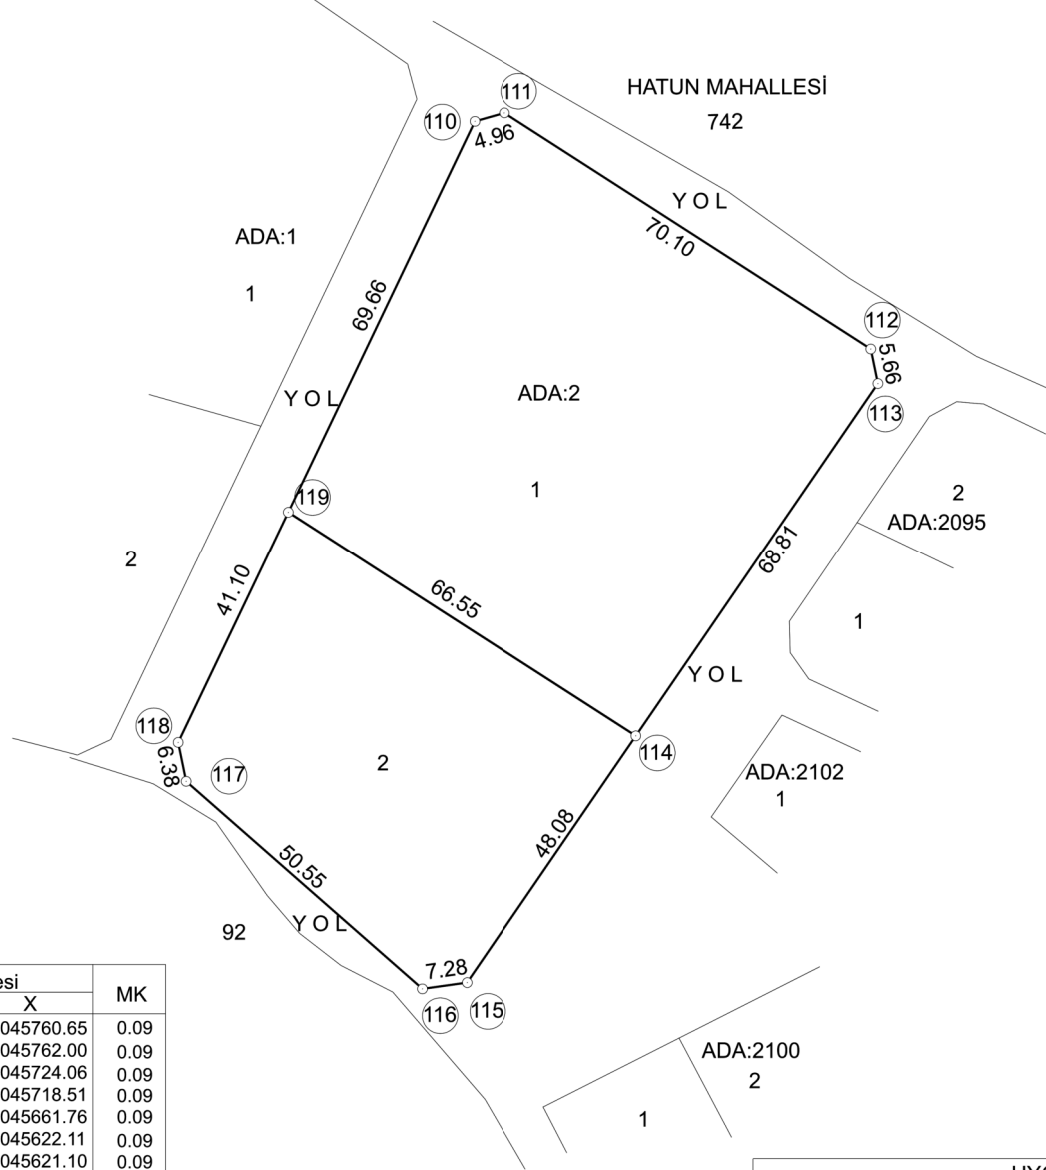
Nokta No	Deprem Öncesi		Deformasyon		Nokta No	Deprem Öncesi		MK
	Y	X	DY	DX		Y	X	
110	508933.93	4045760.88	0.37	0.23	110	508933.56	4045760.65	0.09
111	508938.70	4045762.23	0.37	0.23	111	508938.33	4045762.00	0.09
112	508997.64	4045724.29	0.37	0.23	112	508997.27	4045724.06	0.09
113	508998.78	4045718.74	0.37	0.23	113	508998.41	4045718.51	0.09
114	508959.87	4045661.99	0.37	0.23	114	508959.50	4045661.76	0.09
115	508932.67	4045622.34	0.37	0.23	115	508932.30	4045622.11	0.09
116	508925.47	4045621.33	0.37	0.23	116	508925.10	4045621.10	0.09
117	508887.48	4045654.68	0.37	0.23	117	508887.11	4045654.45	0.09
118	508886.19	4045660.93	0.37	0.23	118	508885.82	4045660.70	0.09
119	508903.91	4045698.02	0.37	0.23	119	508903.54	4045697.79	0.09
